HO- 980  
Knock-Franklin Farm  
15681 Old Frederick Road  
Lisbon vicinity

# Maryland Historical Trust Maryland Inventory of Historic Properties Form

Inventory No. HO-980

historic Knock-Franklin Farm

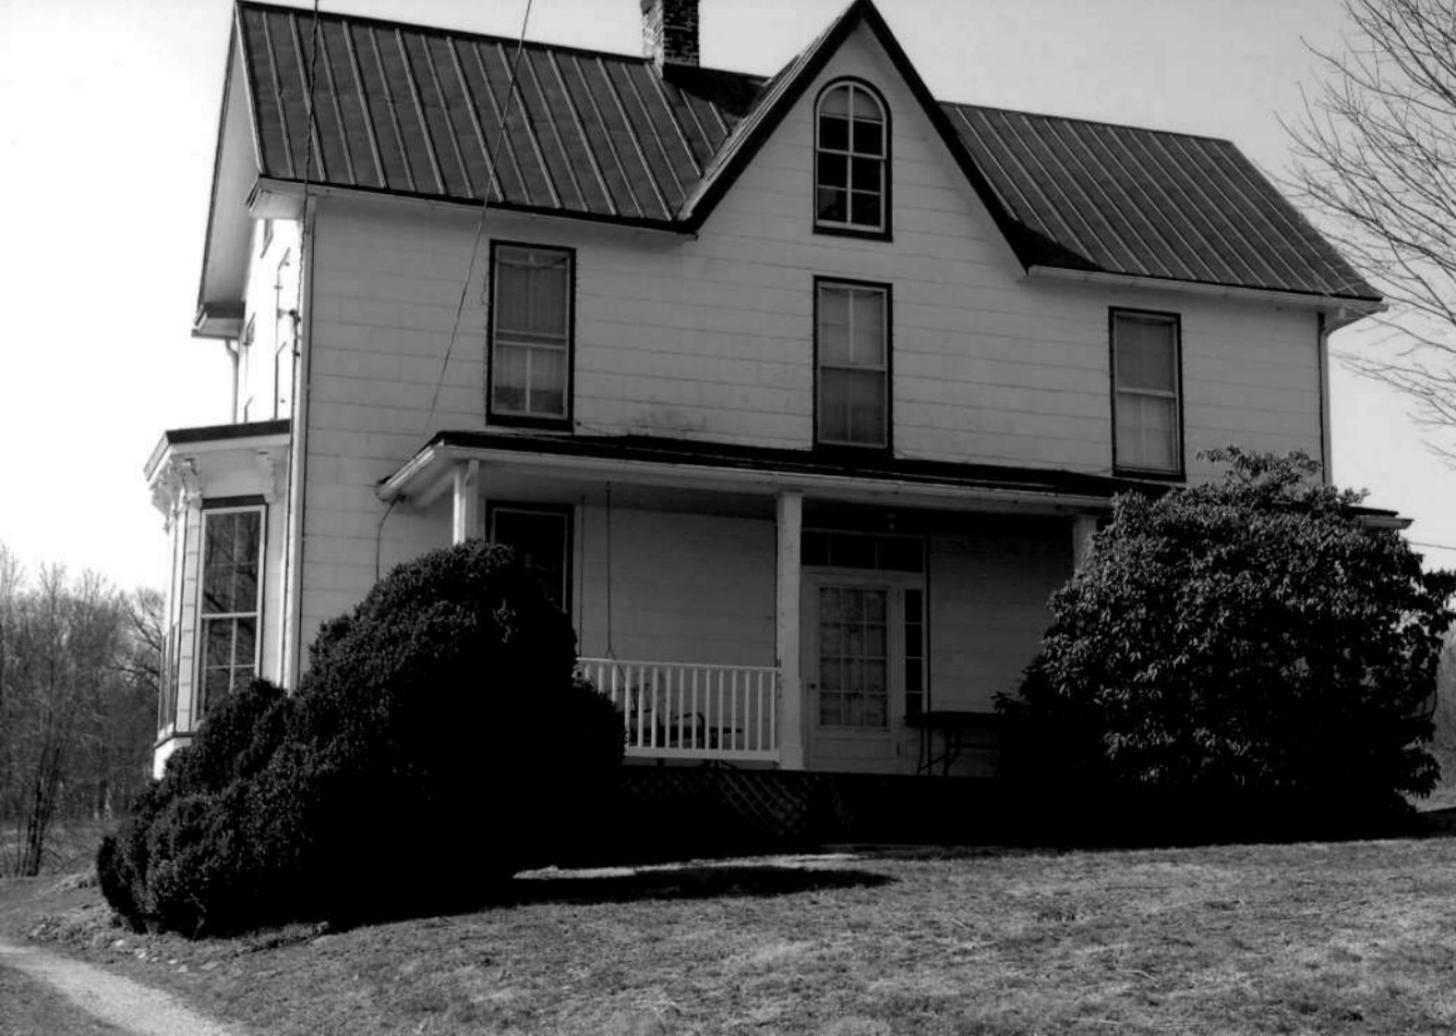
1 of 14

On the northeast elevation, the first story has a center entrance with paired doors that have two panels in each door; the panels have sunken fields and bolection panel moulds. The top panels have semi-circular arched tops. The door has a mineral knob. There are sidelights with two lights over one bolection-moulded panel, but these moulds are different from those on the doors. The doors panels have an ogee and bevel with a cavetto on the back side of it, while the sidelights have an ovolo and bead, with a different cavetto mould on the back side of it. The glass is frosted with a pattern of rosettes between diagonal lines that end with circles. There is a three-light transom that has the same glass as the sidelights. Both the transom and sidelights have mortised and tenoned and pinned muntins. There is one tall four-over-four sash to each side of the doorway, with a wide vertical mullion, and the corners of the sash are mortised and tenoned and pinned. The windows have a narrow mitered frame with a beaded inner edge. There is a three-bay, one-story porch that has a new wood deck, four square chamfered wood posts, a wood box cornice, and a hipped roof with asphalt shingles. The soffit of the porch has slats that have beaded edges, with gaps between the slats. The second story has three typical four-over-four sash, but they are shorter than are those on the first story. There is a wood box cornice with returns, made of narrow beaded boards. There is a central gabled wall dormer with semi-circular four-over-four sash.

House, northeast elevation

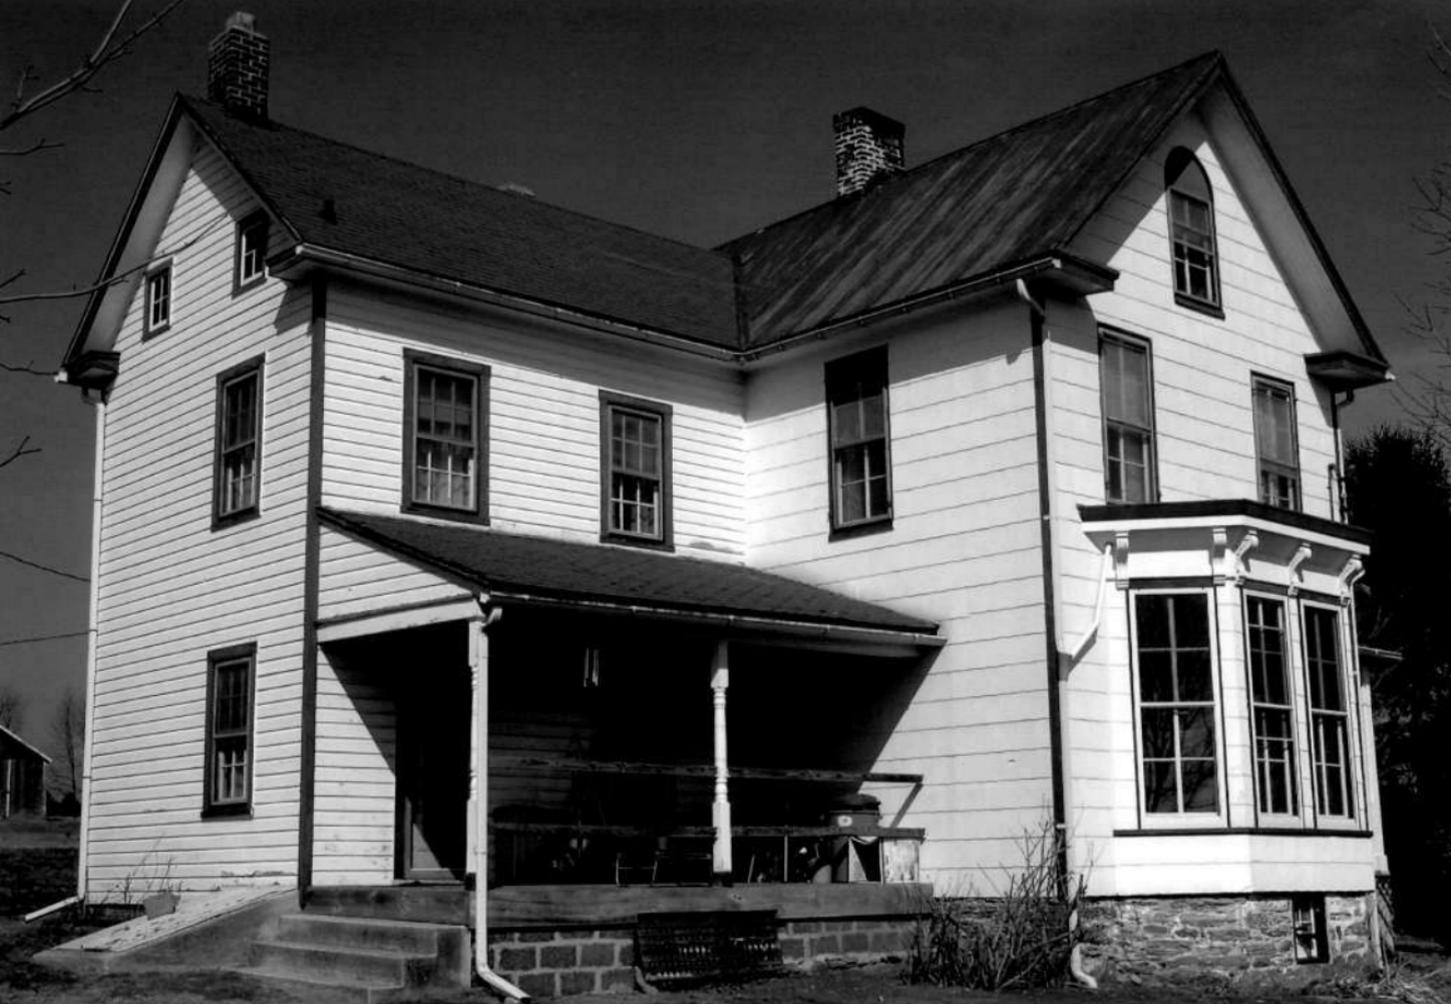
2 of 14

The southeast elevation has a three-sided stone foundation beneath the bay window, with a four-light casement sash in a plain frame in the center. The first story has a bay window with two four-over-four sash on the southeast, and one four-over-four sash to each side. There are sawn brackets on the cornice, made of three sandwiched pieces of lumber, with reeding on the front of the center piece. The sides of the bracket have a jig-sawn foliate design. The second story has two typical four-over-four sash, and the gable end has a semi-circular four-over-four sash like that on the northeast. The southwest elevation of the main block has the ell in the center bay. The first story has no openings in the south or west bays. The second story has a typical four-over-four sash in the south bay, with no opening in the west bay.

House southwest & southeast  
elevations

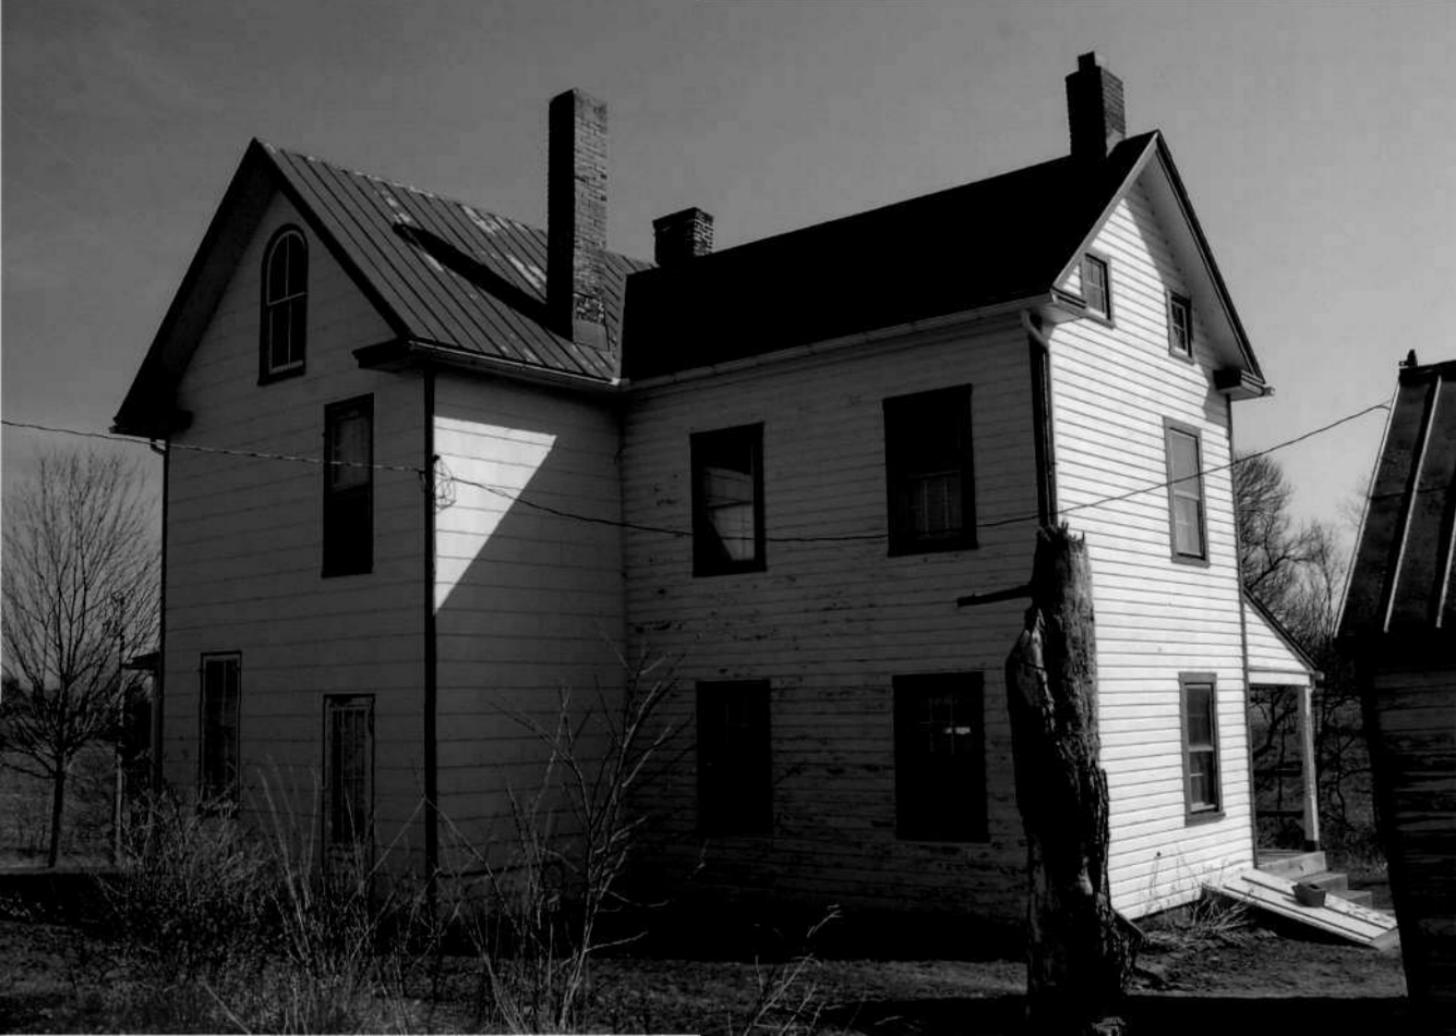
3 of 14

House northwest & southwest  
elevations

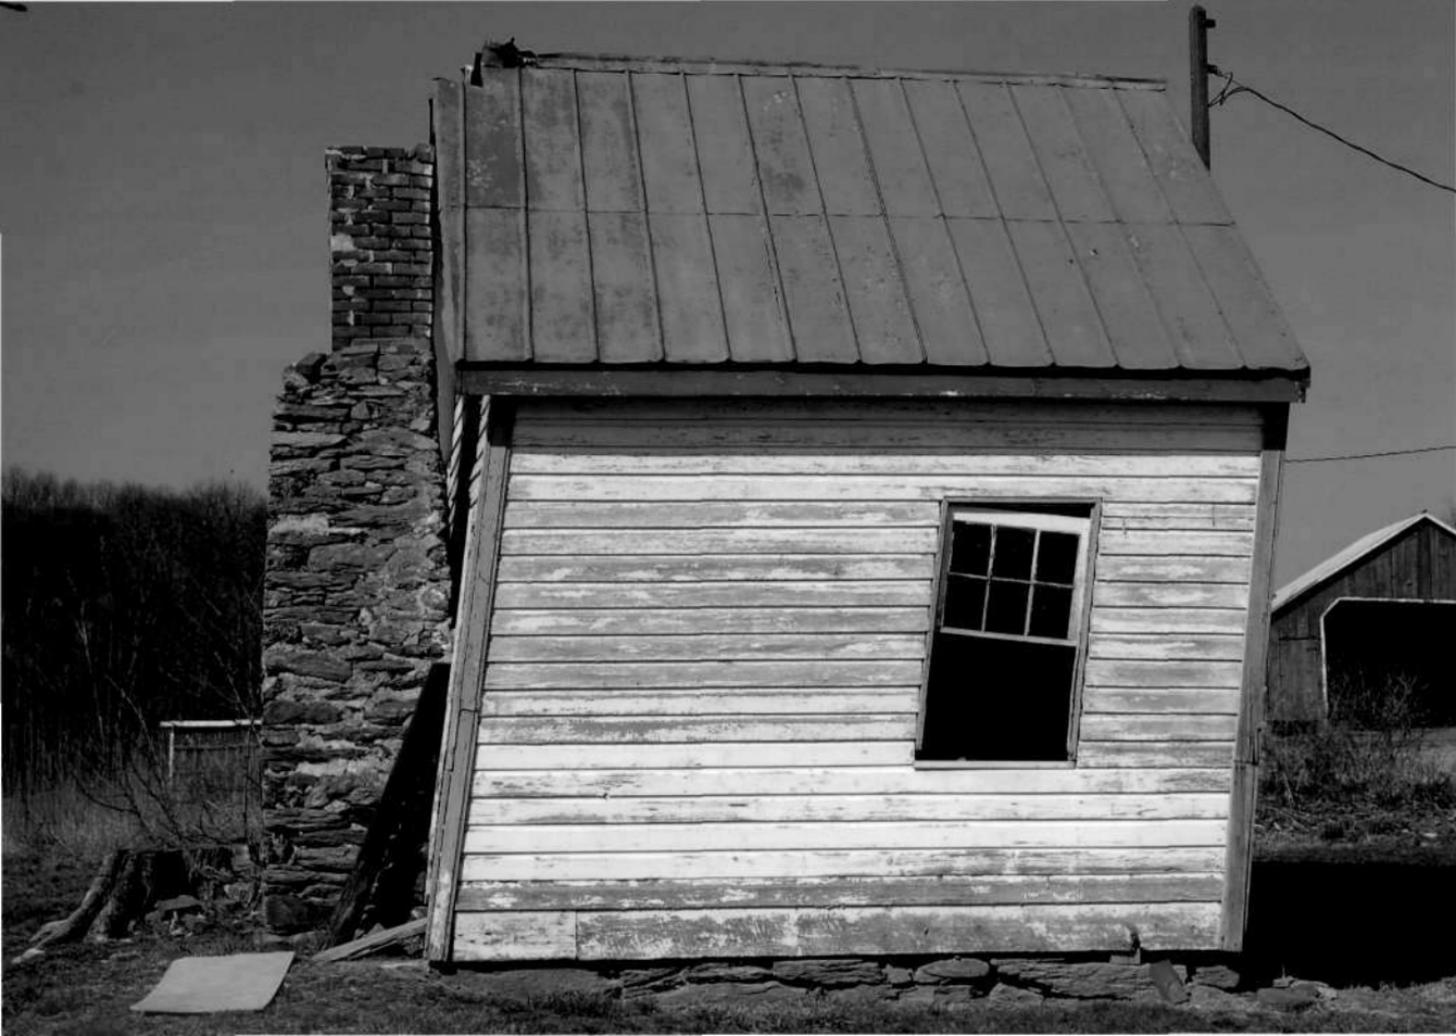
4 of 14

The summer kitchen is located about five feet southwest of the ell. It is a one-story, one-bay square structure with a rubble stone foundation, German siding, and a gable roof with inverted-V-seam metal and a northeast-southwest ridge. There is a large exterior stone and brick chimney on the southwest end. The building is racking to the northeast, and has separated from the chimney. The northeast elevation has a tongue-and-grooved vertical board door set to the east, with head-cut trim. The southeast elevation has a six-over-six double-hung sash set just east of center. The sash is mortised and tenoned and pinned at the corners, and is set in a plain mitered frame. The siding is fastened with wire nails. The southwest elevation has a beaded-edge vertical-board door set south of the fireplace in a plain mitered frame. The northwest elevation has a six-over-six sash set west of center, with the corner joints of the sash nailed, and it is set in a plain mitered frame. The interior has 4-inch-wide tongue-and-grooved flooring that appears to be pine, and runs northeast-southwest. It is set on sleepers that appear to be hewn. The walls are constructed of circular-sawn 2 by 4s, with two 2 by 4s ganged together for most of the corners and the southeast and northwest plates. There are pole rafters that are mitered at the ridge, and they appear to be mitered and nailed to the plate. They support shingle lath. The interior is one completely open space. The stone fireplace on the southwest end is parged on the front, has straight jambs with traces of parging, and has two iron bars for the lintel. There is an iron crane on the west jamb and the bracket of the crane has numerous tight twists in it.

Summer kitchen, southeast  
elevation

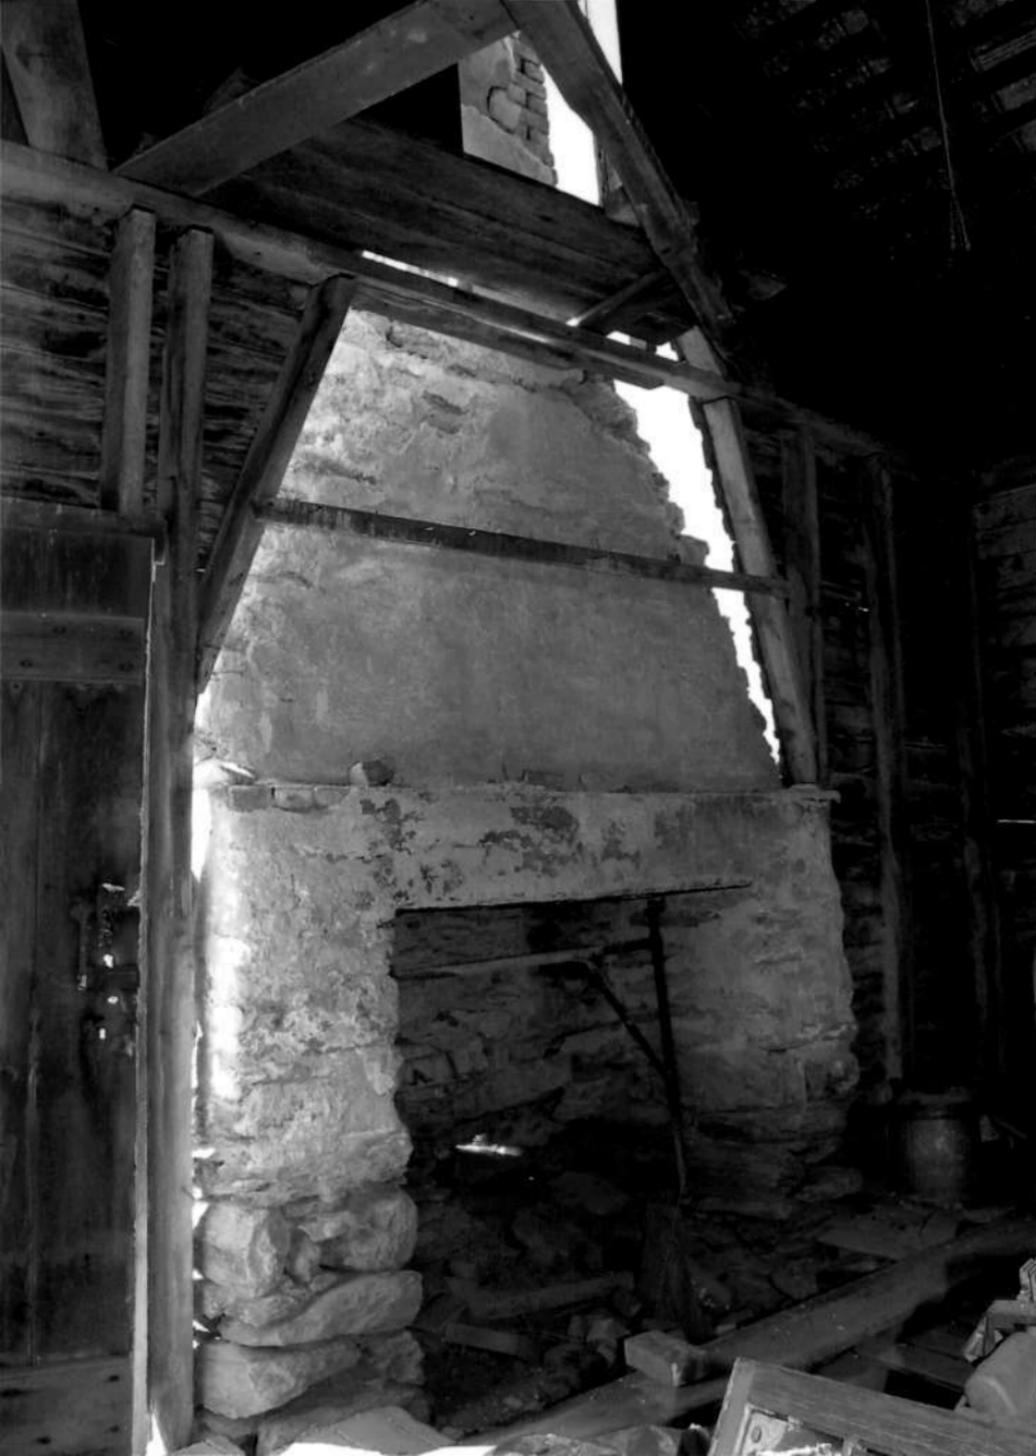
5 of 14

Summer kitchen, interior, view  
southwest

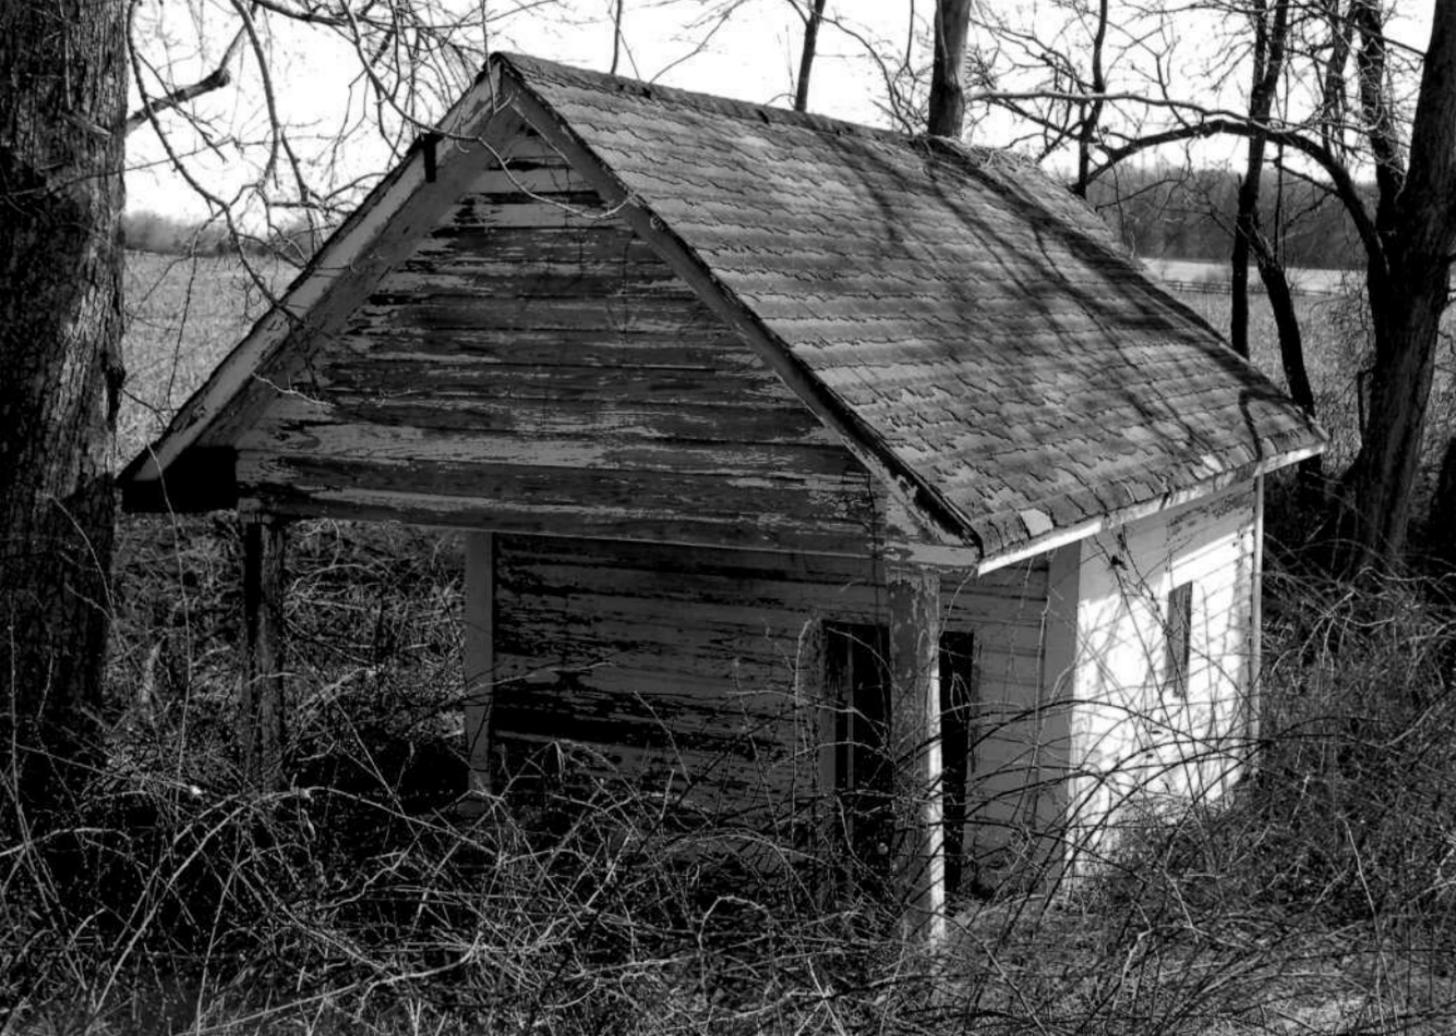
6 of 14

The springhouse is located about 75 feet southeast of the house, and down the hill from it. It is a one-story, one-bay square structure with a rubble stone foundation, German siding, and a gable roof with asphalt shingles and a northwest-southeast ridge. The roof is cantilevered on the northwest and supported by two square posts that have chamfered corners. The northwest elevation has a door with vertical boards set to the west, and it is hung on T hinges. There are sunken stone walls on the northwest, southwest, and southeast, beneath the cantilevered roof, and these walls have an opening in the northwest for the spring. There are also brick steps coming through the wall to the west of the spring, giving access to the floor of this vestibule beneath the cantilever. The northeast elevation has a two-light sash. The southeast elevation has no openings, and the water comes through the foundation and runs to the southeast toward a small stream. The southwest elevation has a two-light sash that matches the northeast. On the interior, there are three brick steps down to the floor of the springhouse. There is a concrete trough on the northwest, north of the steps, and on the northeast and southeast sides. The floor is completely flooded. There is a wood shelf on top of the southeast foundation wall. The walls and ceiling have drywall, and there is an open hatch in the center of the ceiling.

Springhouse, northwest & southwest  
elevations

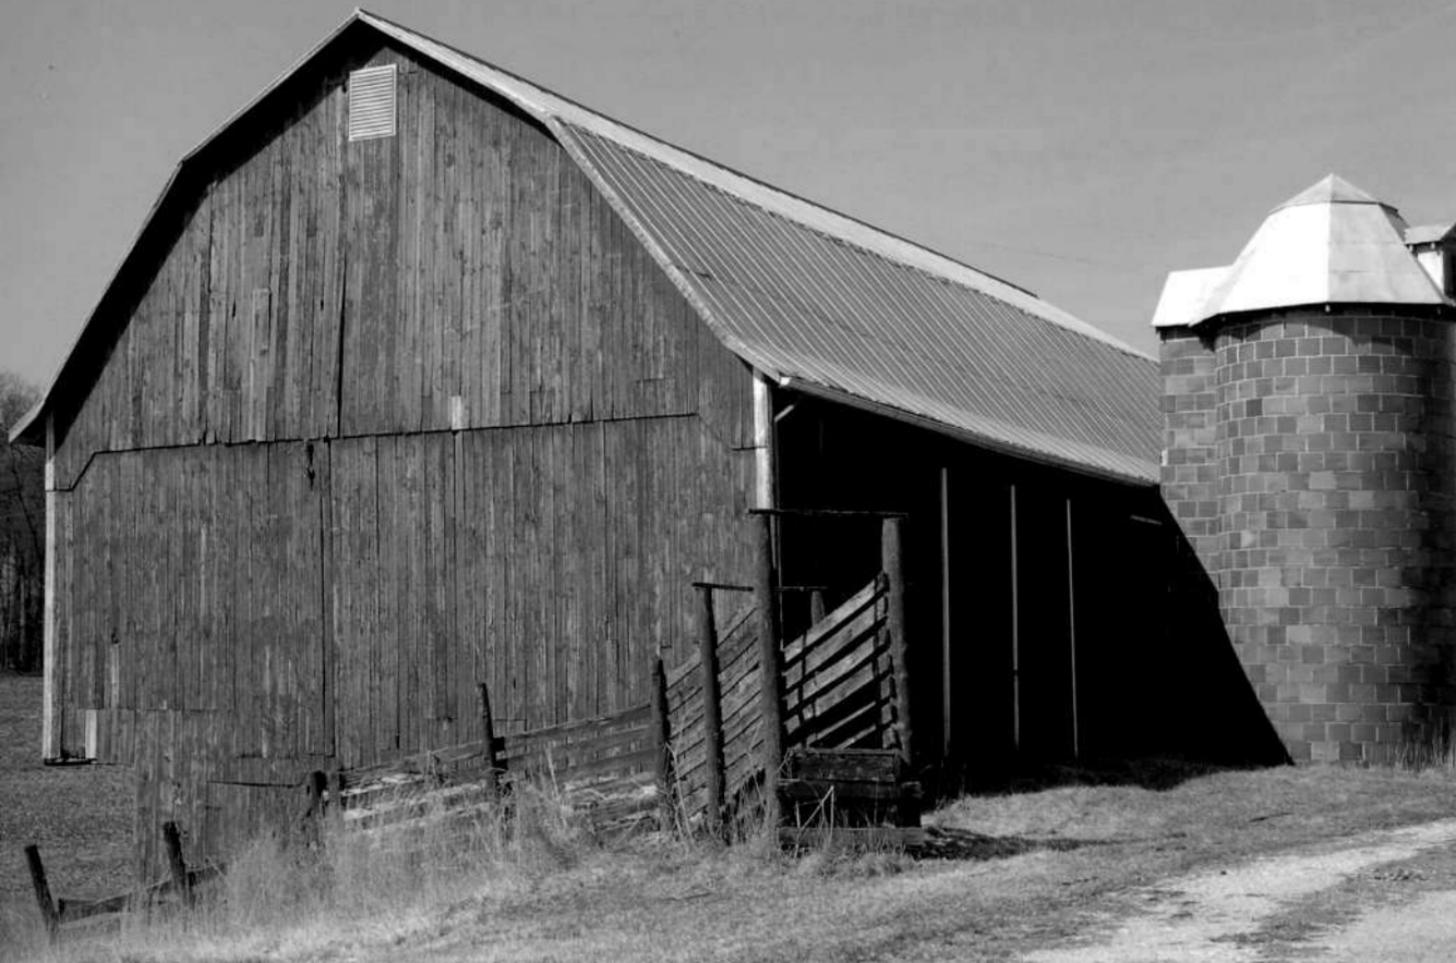
7 of 14

The barn is located about 150 feet northwest of the house. It is banked into a hill on the northeast, with an overshoot that faces southwest. The lower story is rubble stone with some concrete patches. There

are vertical boards on the northeast and northwest elevations of the upper story and beaded-edge-and-center vertical boards on the southeast and southwest. There is a gambrel roof with inverted-V-seam metal, a northwest-southeast ridge and it has a kick at the eaves. On the northeast elevation the barn is five bays, with no openings in the center bay or the end bays. There are paired wagon doors in the other two bays, and they are constructed of beaded-edge-and-center vertical boards and hung on rollers. The roof has open eaves. The siding boards have notches in them for earlier rafters, and these notches are spaced 29 to 32 inches on centers. The existing plate blocks these notches. The siding boards have cut nails and wire nails. It appears that the roof must have been completely rebuilt, and the plate replaced, but that the northeast wall is not rebuilt. There is a terra cotta tile silo on the northeast side, in the center, and it has an octagonal metal roof. There is a stone ramp wall at the north end of the northernmost door. The southeast elevation stone foundation has quoins at the end of it, which end just south of center. To the south of these quoins is a beaded-edge-and-center vertical-board wall over a concrete foundation, and this wall has a Dutch door hung on small machine-made strap hinges. There is a boarded-up window opening in the center of the stone section of the foundation. The upper story has no openings, but the gambrel end has a modern aluminum vent.

Barn, southeast & northeast elevations

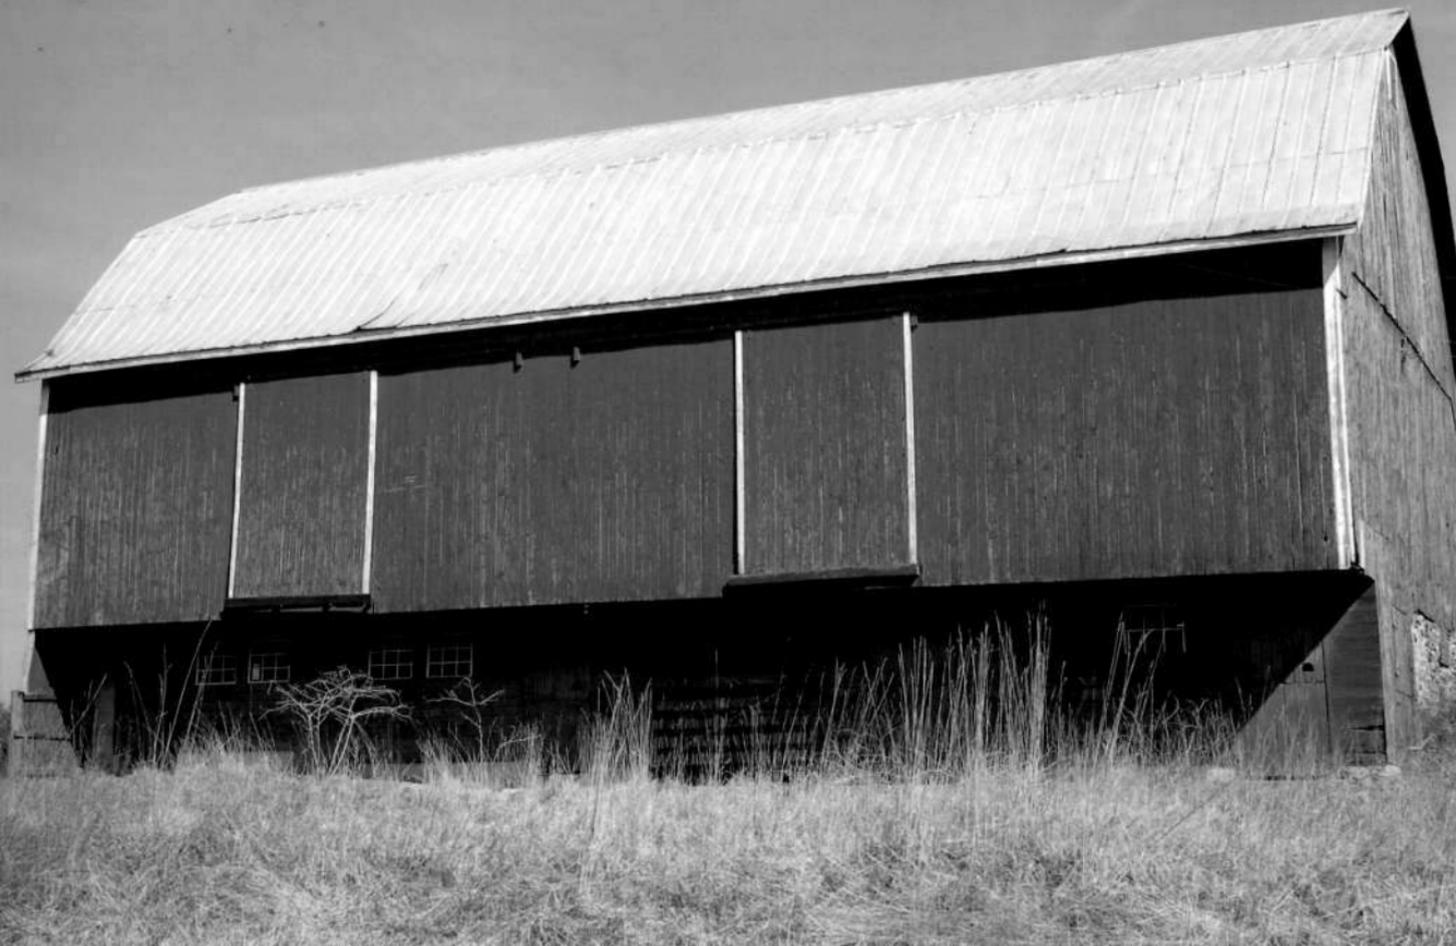
8 of 14

The southwest elevation foundation is a concrete wall, with horizontal board siding to the south and beaded-edge-and-center horizontal boards to the west. From west to south there is a beaded-edge-and-center vertical-board Dutch door on machine-made small strap hinges, and this door is typical; a pair of nine-light fixed sash; a typical door, another pair of nine-light fixed sash, another typical door, the wall opened up for a large wood gate; a typical door; a single nine-light sash; and a typical door. The opening in the center apparently originally had a door to the west then a post, and probably windows to the south. This reconstruction is based on notches in the west post for door battens and vertical trim pieces that remain in place; there is no good physical evidence for the windows. The upper story has no openings in the end and center bays, and single large vertical beaded-edge-and-center board doors hung on rollers in the other two bays, opposite the wagon doors in the northeast elevation. The overshoot joists are circular-sawn on top and bottom. On the northwest elevation the lower story has a stone foundation with some vertical boards above it, and there are three windows in the boarded section; two of the windows have three lights, while the west sash is one light. The west end is extended with poured concrete, and vertical boards close off the overshoot end. The west end of the stone is clean, as if it was finished here once. There are no openings on the upper story other than an aluminum vent in the gambrel end.

Barn, southwest elevation

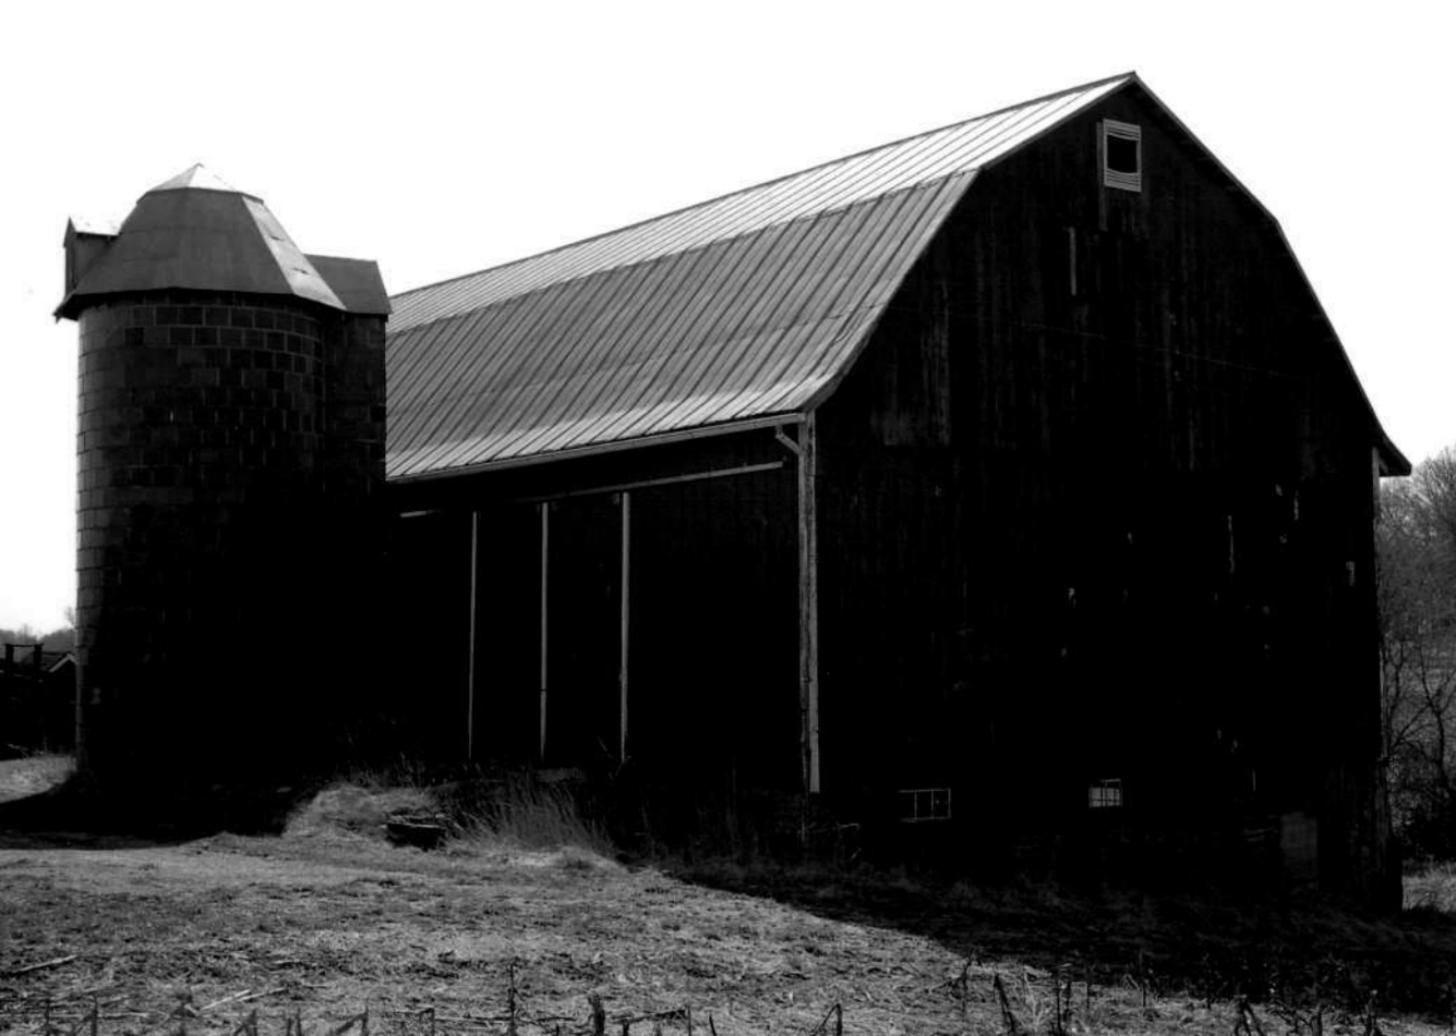
9 of 14

Barn, northeast & northwest elevations

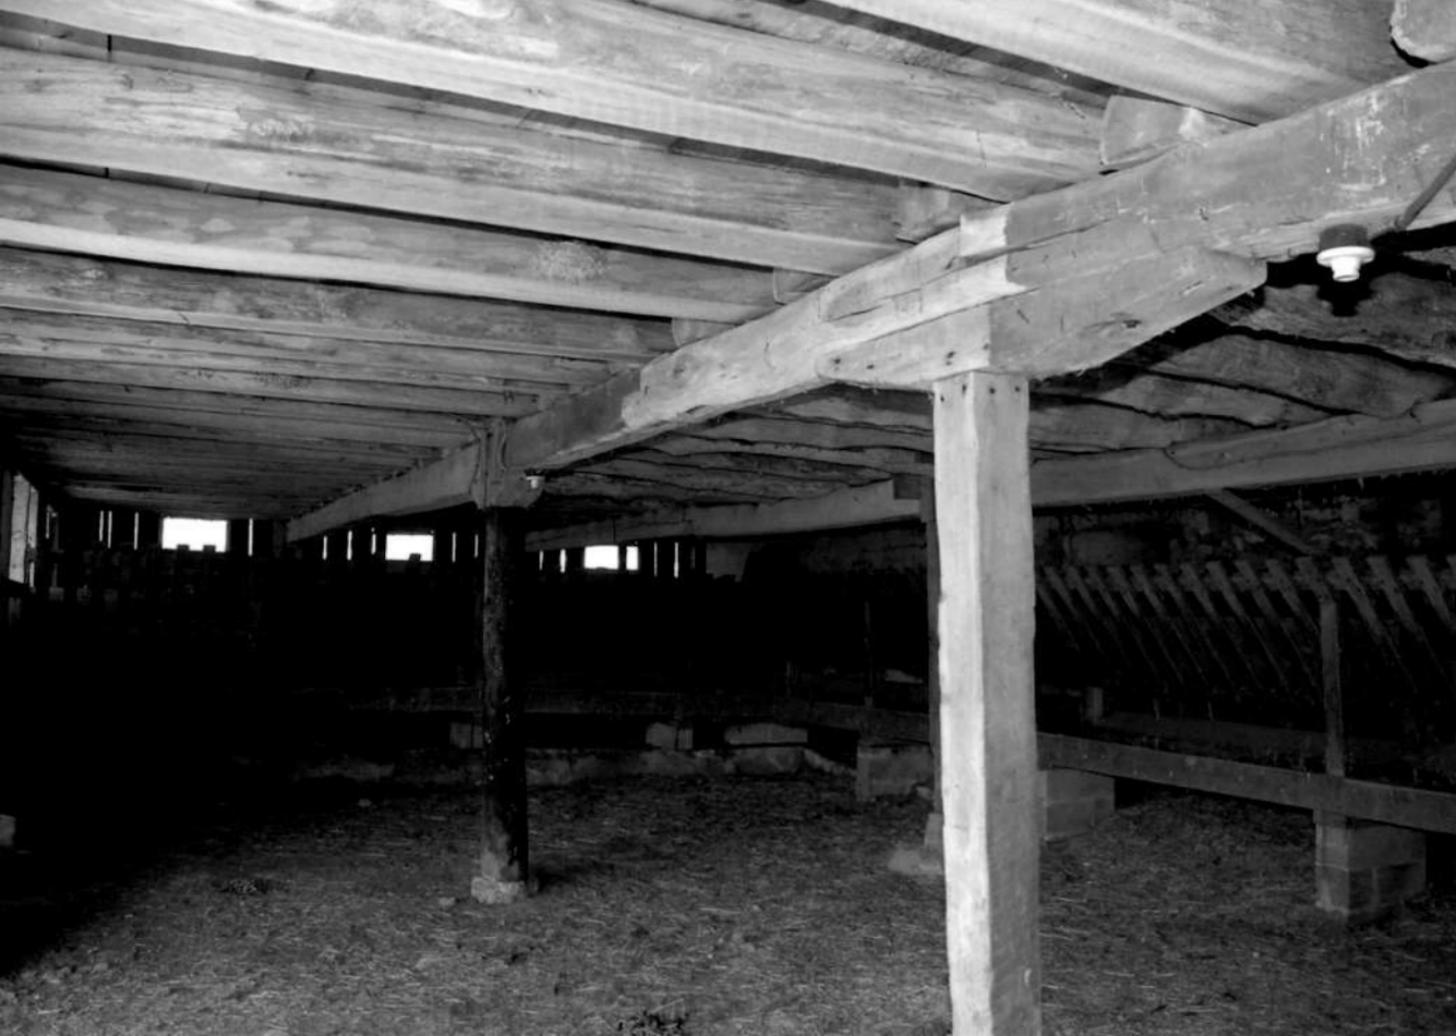
10 of 14

On the interior of the lower story, the three bays to the southeast have stone on the northeast and southeast, and the southeast wall turns the corner to the southwest, next to the door. The two bays of the barn to the northwest have poured concrete on the northeast wall. There are two summer beams that run northwest-southeast. The southwest summer beam was the original plate on the overshoot lower wall

and is hewn, with a half-lap scarf joint. The northeast summer beam is added, and is circular-sawn, with small half-lap scarf joints. The southeast end of this summer beam sits on a block of wood on the windowsill, and the summer extends through all five bays. The southwest summer beam in the two northwest bays matches the northeast summer beam and has a beveled butt joint where it meets the hewn section. There is a circular-sawn bolster at this joint. This end of the hewn summer does not mark the end of the original barn, but is several feet southeast of the original end. The joists run northeast-southwest and lap at the old plate that is now the southwest summer beam. The joists on the three southeast bays are three-quarter-round logs that appear to have cantilevered on the southwest and to have been cut off. The added joists at the southeast end have dropped on the southwest, causing the northeast ends to have kicked up. The northwest end joists are circular-sawn on top and bottom and end at the southwest summer, but there is no evidence that they were cut off. The southwest joists are handled the same way as those on the southeast end. The overshoot wall is constructed of a circular-sawn heavy timber frame. The center of the original three bays has plain board flooring on the upper story, while the flanking original bays have original battens under the seams in the floorboards. There are peg hooks on the southeast end of the barn and metal stanchions at the northwest end. The three southeast bays, plus some of the addition to the northwest, are open, with a trough and hayrack on the northwest and northeast sides, and an aisle that runs along the northeast wall.

Barn, interior, lower story,  
view north

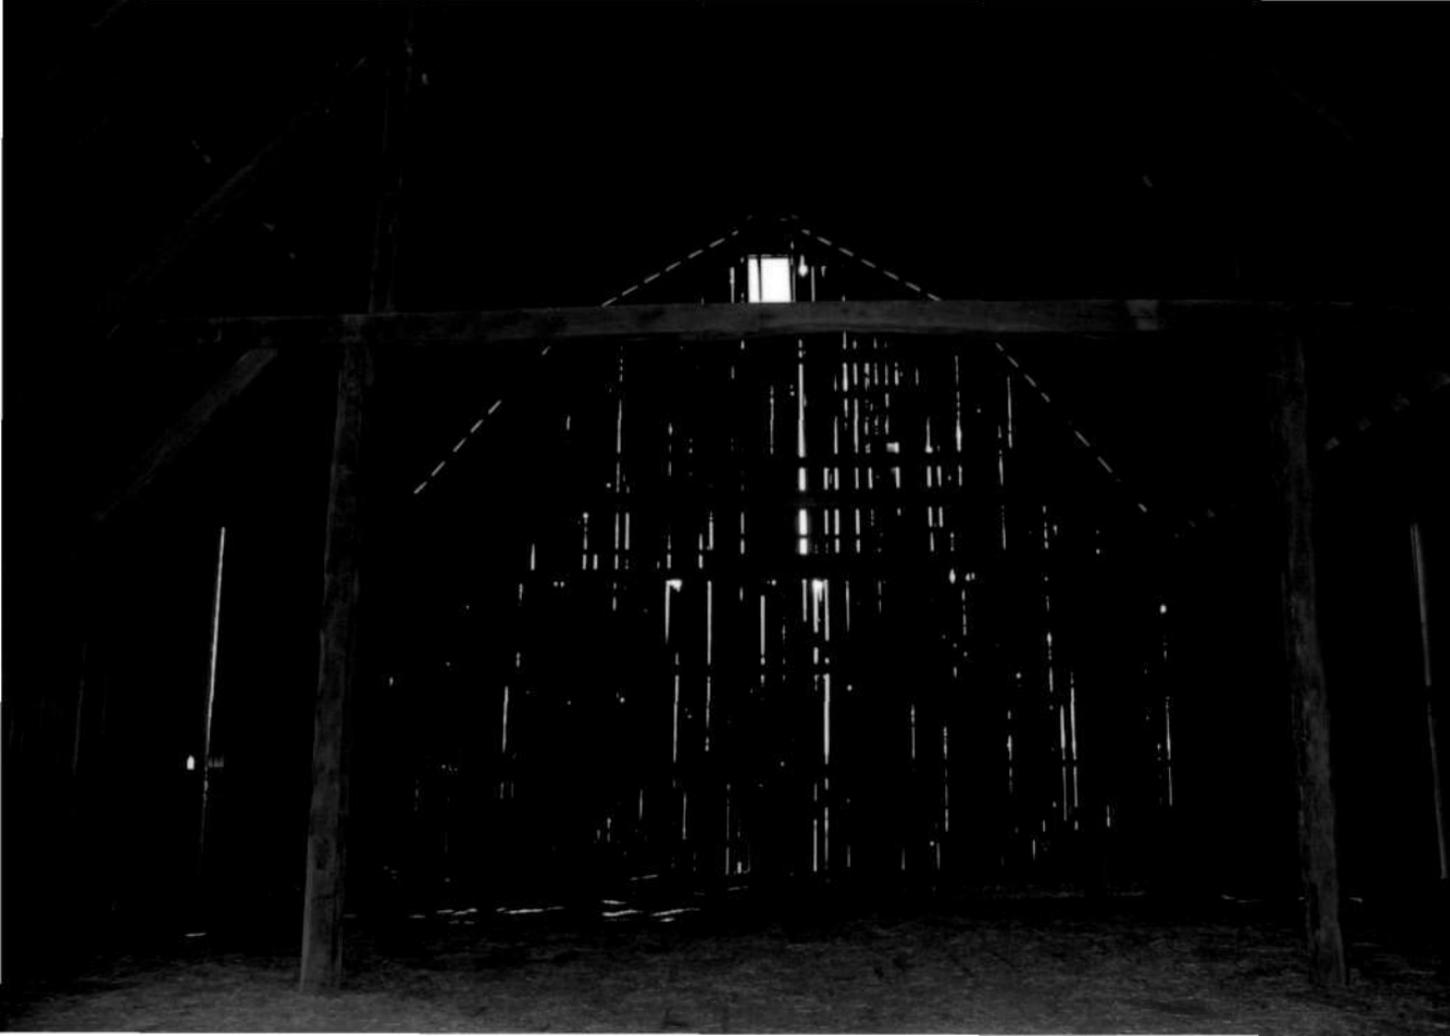
11 of 14

The upper story of the barn has hay mows on both ends and one in the center, with wagon floors between them. There is a granary in the north corner that has tongue-and-grooved horizontal boards fastened with wire nails and a matching door that is hung on butterfly hinges. The granary has a center aisle that runs to the northwest, with two bins each on the northeast and southwest sides of the aisle. The barn is constructed of a mortised and tenoned and pegged heavy timber braced frame. Some of the posts in the northeast and southwest wall were left in place while others are reused hewn timbers with abandoned mortises. The center four girts are circular-sawn, and are of one piece, suggesting that the bents were taken apart to enlarge the barn, and in the process the roof was completely rebuilt with circular-sawn timber. The southeast end has a new girt added on top of the original, in order to extend the barn out to the southeast. The original corner post remains in place with mortises on the northwest face for horizontals that were once in the southwest wall. There are no mortises in the southwest face, indicating that this wall did not extend beyond the corner post; this corner post is aligned with the original plate and southwest summer beam below, and there was apparently no cantilever on this barn originally. The rafters are 2 by 4s that are mitered and butted at the ridge and are lapped at the purlins. The framing uses dropped girts with iron straps on them, except in the east corner. The original siding was apparently left in place on the northeast elevation, with salvaged siding added to the addition, being moved to the northwest end where it would not be seen from the house. The northeast plate is hewn and does not appear to be altered. It has half-lap scarf joints with beveled abutments. There are two face pegs. There is a hayfork in the ridge that runs along a metal track, and a rope and pulley off to the northeast on the first interior bent to the southeast of the wagon floor.

Barn, interior, upper story, view  
southeast

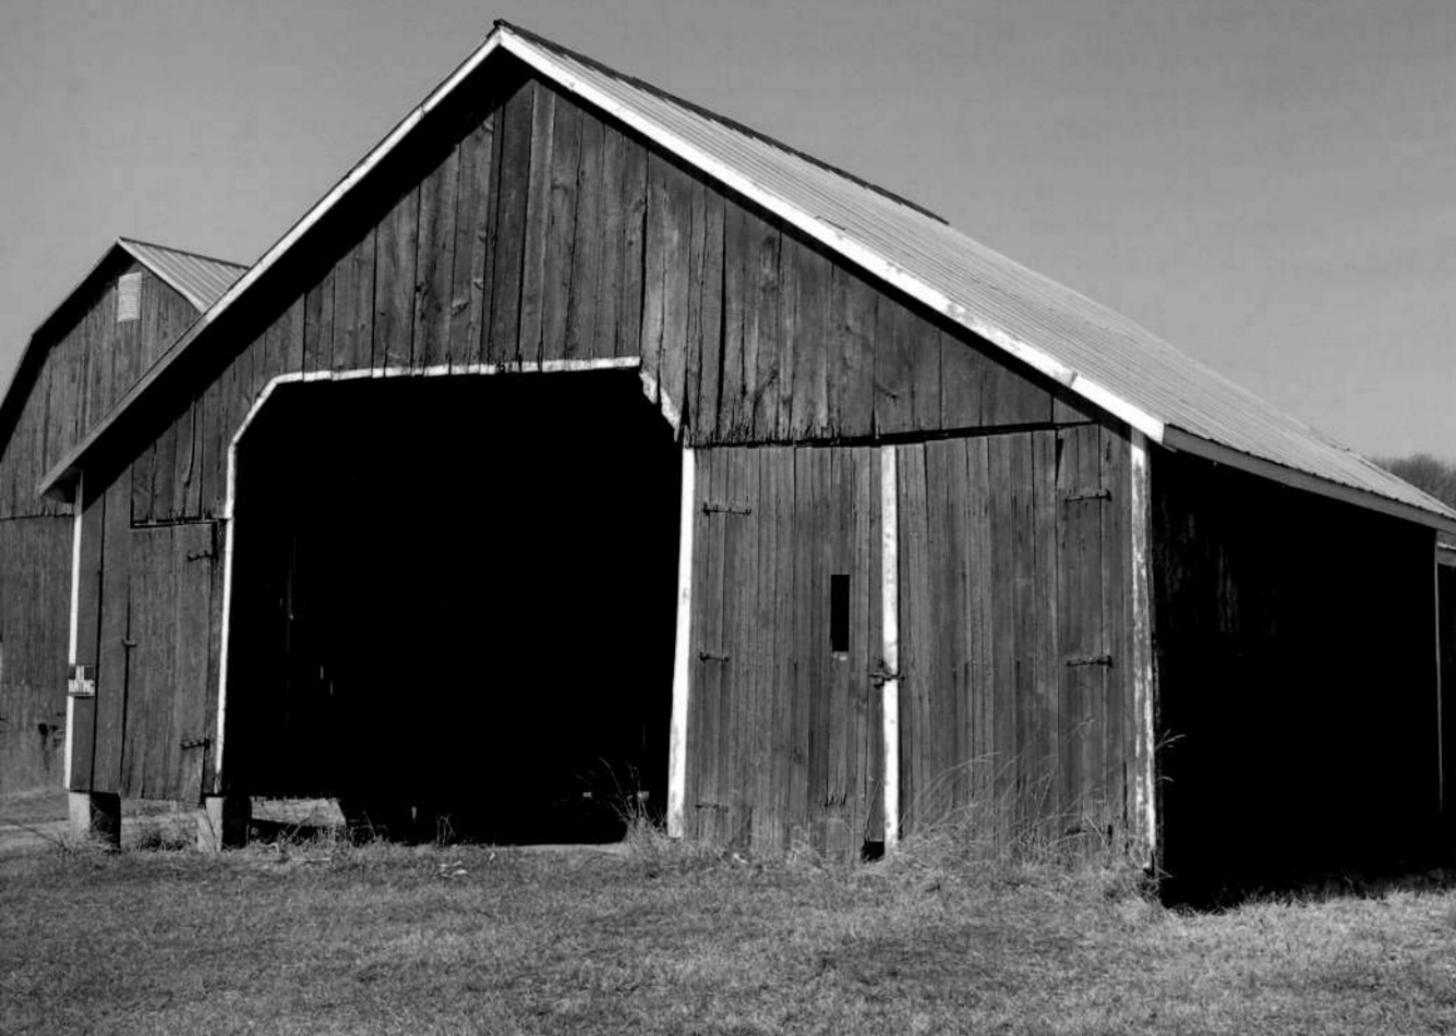
12 of 14

There is a wagon shed located about 30 feet east of the barn. It is a one-story, three-bay by two-bay frame structure with vertical board siding on the southeast, northeast, and northwest elevations and vertical board slats on the southwest. It is set on concrete piers and has a gable roof with a northwest-southeast ridge and inverted-V-seam metal. The southeast elevation has a large opening in the center, with no evidence of doors ever being here. There is a vertical-board door to the south hung on small machine-made strap hinges, and a pair of beaded-edge-and-center vertical-board doors to the east, also hung on machine-made strap hinges. The gable is longer on the northeast, and could be extended. The southwest and northeast elevations have no openings. On the northwest elevation a tractor shed has been added. The northwest end of the wagon shed has pintles for door hinges in the center opening and a door has been added to the west, with no opening to the north. The wagon shed has a circular-sawn heavy timber mortised and tenoned frame that is all wire-nailed. There are 2 by 4 rafters that are circular sawn and are mitered and butted at the ridge. The center bay of the wagon shed has slats on the southwest side and boards on the northeast side. The tractor shed has 4 by 4 circular-sawn posts, is nailed together with wire nails, and has a CMU foundation and vertical board siding. It also has an off-center gable with a northwest-southeast ridge and inverted V-seam metal roofing. The rafters are 2 by 6s.

Wagon shed, northeast & southeast  
elevations
